Report on the Texas Rapid Assessment Method (TXRAM) for Streams

July 2017

**Proposed Lake Palo Pinto Storage Restoration Project at Turkey Peak
(Turkey Peak Reservoir)**

HDR Engineering, Inc.

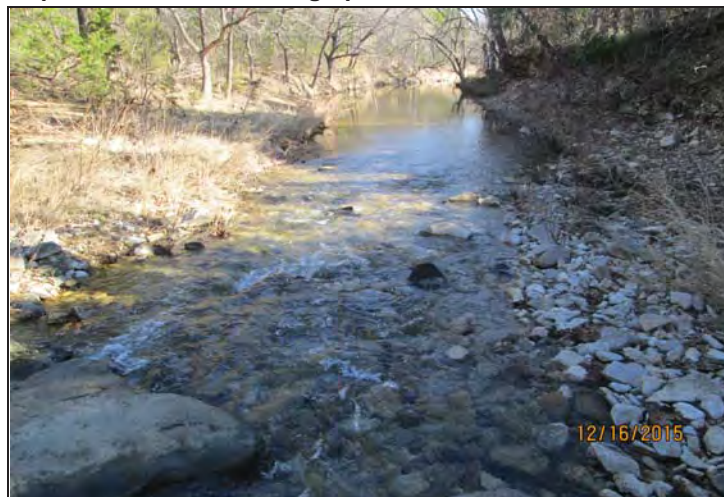
Facing northeast (downstream) from near the downstream end of the SAR. View of a small riffle area entering a long shallow pool.

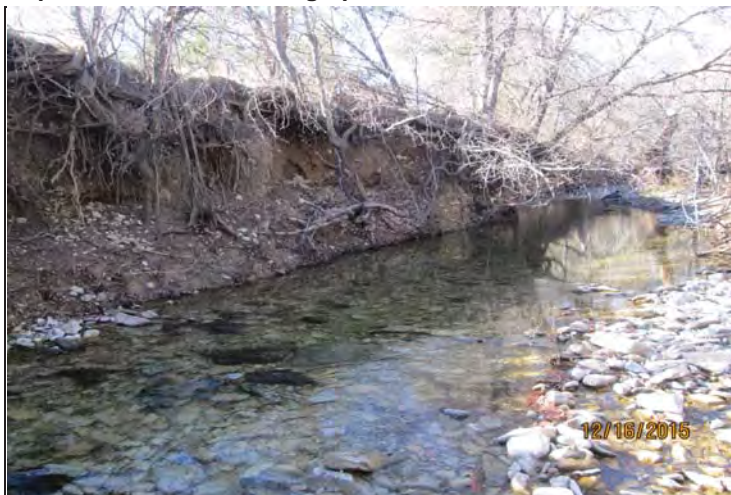
Facing northeast (downstream) near the downstream end of the SAR. Note the steep vertical banks along the left bank that average 8 feet in height, however, this is an isolated occurrence along the reach, which has slight channel incision.

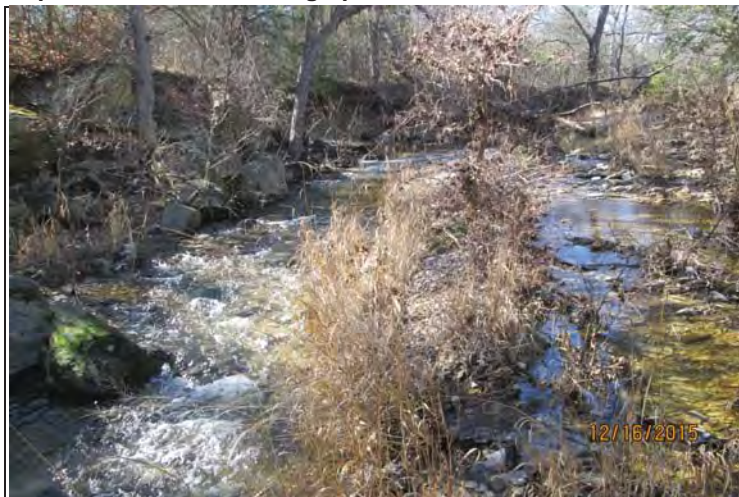
Facing southwest (upstream) at channel braid and small island covered with terrestrial vegetation found in the middle section of SAR.

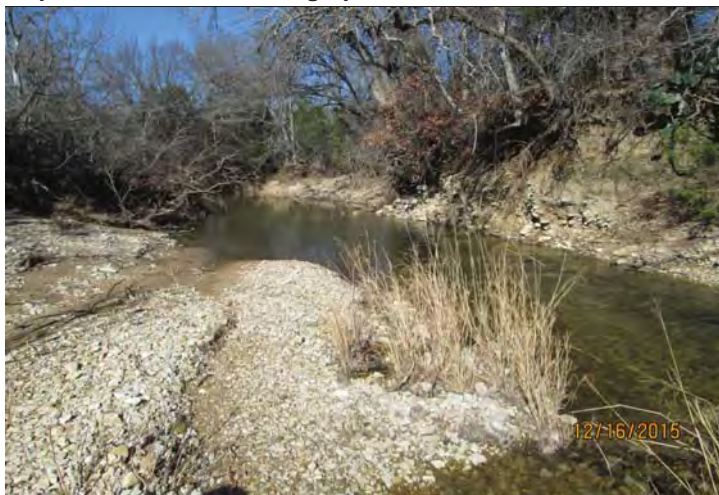
Facing north (downstream) near the downstream end of SAR. Note the gravel bar along the left bank at this location.

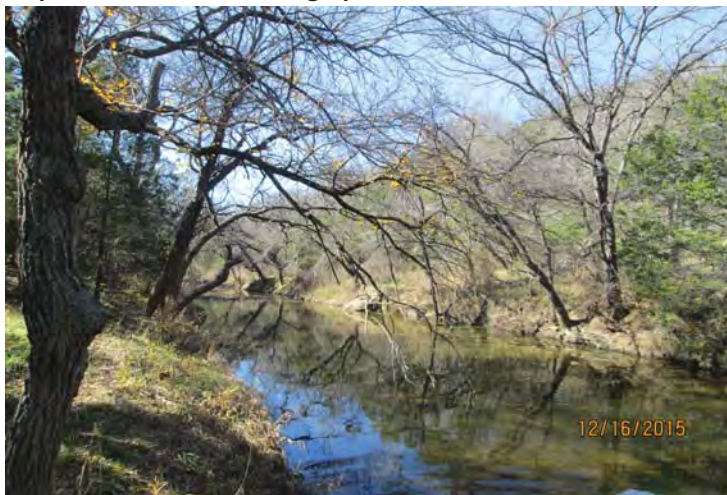
Facing southwest (upstream) from the downstream end of SAR. Palo Pinto Creek at this location is characterized by a wide, shallow pool over a dominantly cobble substrate with a wooded riparian buffer.

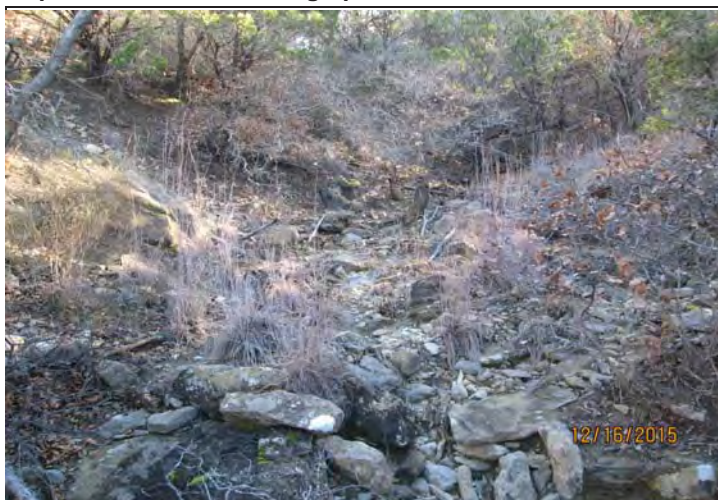
Facing northwest (downstream) in the middle section of SAR. Ephemeral stream that is dry under normal conditions. Large boulder and cobble were the dominant substrate materials.

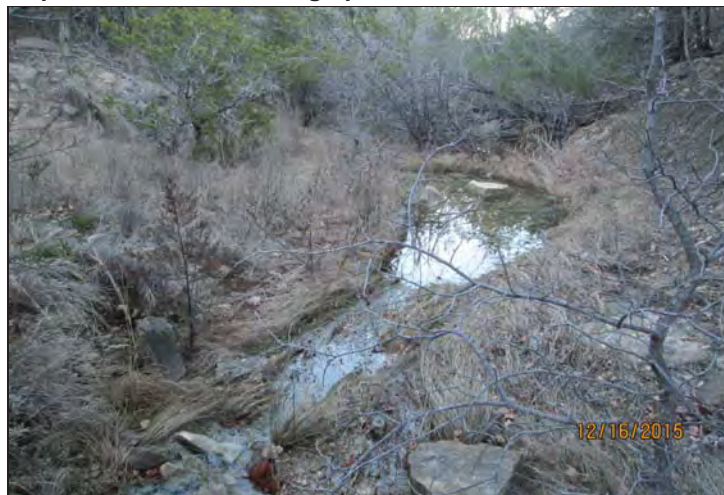
Facing west-southwest (upstream) near the upstream end of SAR. Ephemeral stream that had water after a recent storm event but is dry under normal conditions. The buffer area along both banks has been partially cleared of juniper.

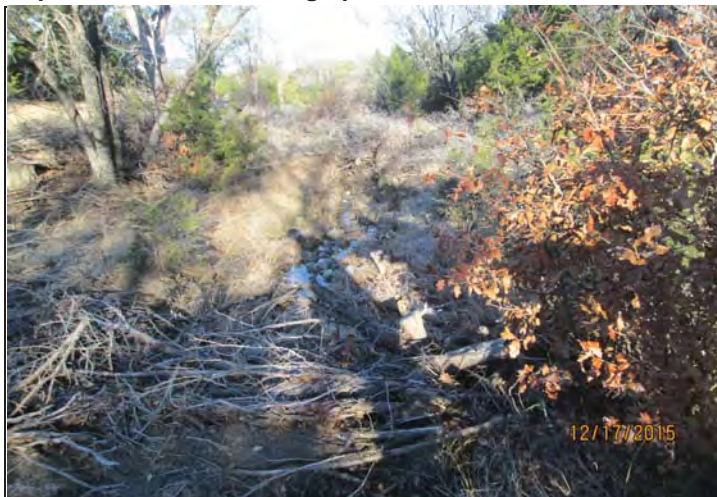
Facing northwest (downstream) from the upper portion of SAR. Note partial removal of juniper in the buffer area.

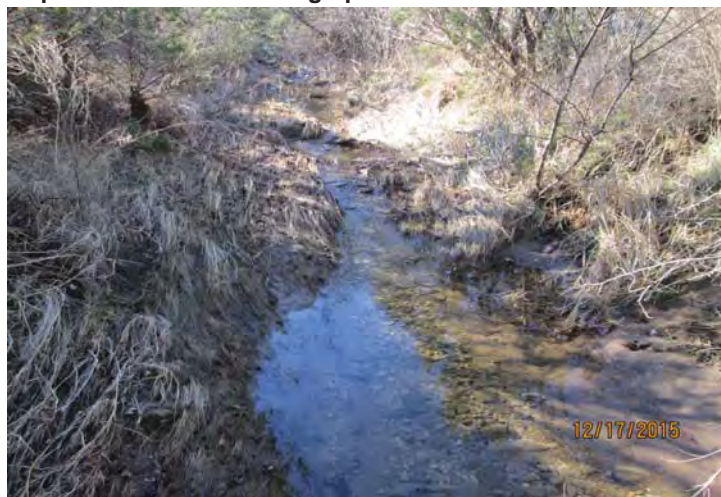
Facing southeast (upstream) from the downstream end of SAR. Flow was observed after recent rainfall but likely intermittent with isolated pools under normal conditions. Substrates were fairly diverse at this site.

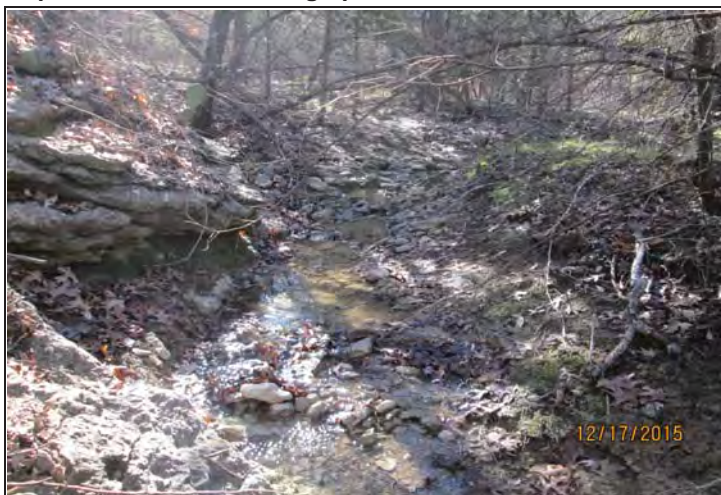
Facing southeast (upstream) in the upstream portion of SAR. This ephemeral tributary was characterized by mostly gravel substrates with noticeable cobble and sand materials. The channel is dry under normal conditions.

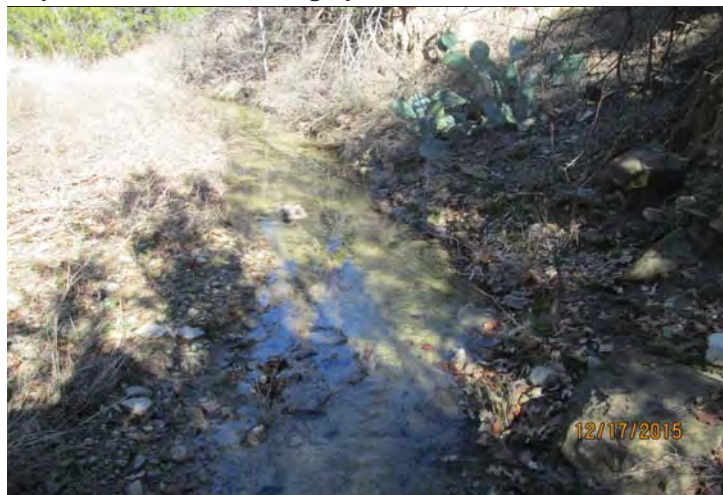
Facing south (downstream) near the upstream portion of SAR. The stream is dry under normal conditions.

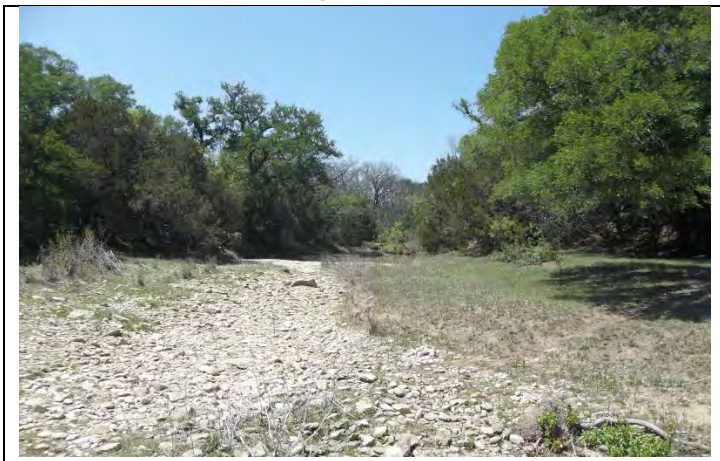
<p>Existing segment of stream (MS-1-3) facing upstream (northwest). A small pool of bedrock substrate was present. Signs of erosion and livestock usage observed.</p>	<p>See TXRAM Reference SAR data and description of proposed activities in mitigation plan. After construction includes enhancement of channel and planting vegetation with livestock exclusion.</p>	<p>See TXRAM Reference SAR data and description of proposed activities in mitigation plan. After monitoring includes natural re-generation and growth of vegetation.</p>	<p>See TXRAM Reference SAR data and description of proposed activities in mitigation plan. At maturity includes target scores for mitigation based on reference.</p>
--	---	---	--	--

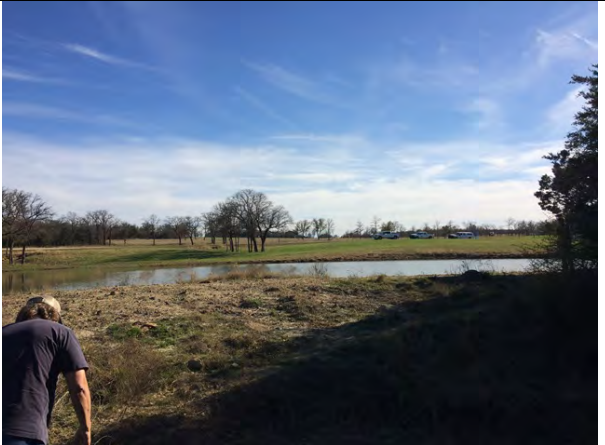
<p>Facing southeast at existing pond that will be removed to restore the proposed SAR OPSR-18-1.</p>	<p>See TXRAM Reference SAR data, design and description of proposed activities in mitigation plan. After construction includes restoration of channel and planting vegetation with livestock exclusion.</p>	<p>See TXRAM Reference SAR data, design and description of proposed activities in mitigation plan. After monitoring includes growth of vegetation.</p>	<p>See TXRAM Reference SAR data, design and description of proposed activities in mitigation plan. At maturity includes target scores for mitigation based on reference.</p>
---	--	---	--	--
