Report on the Texas Rapid Assessment Method (TXRAM) for Streams

July 2017

**Proposed Lake Palo Pinto Storage Restoration Project at Turkey Peak
(Turkey Peak Reservoir)**

HDR Engineering, Inc.

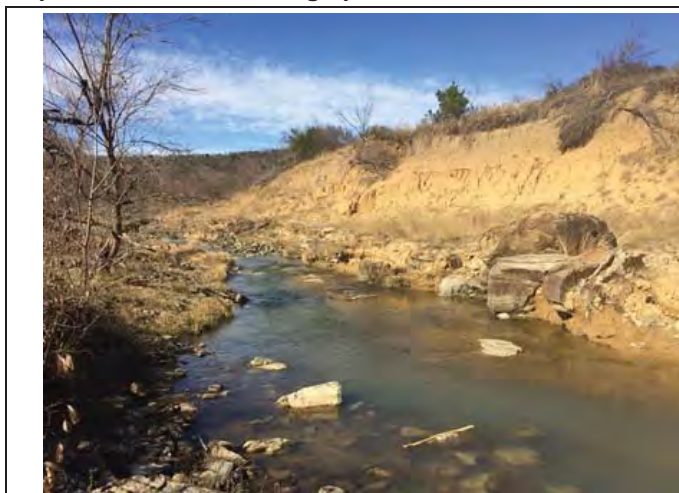
Facing upstream near the middle of the SAR, looking at eroded bank.

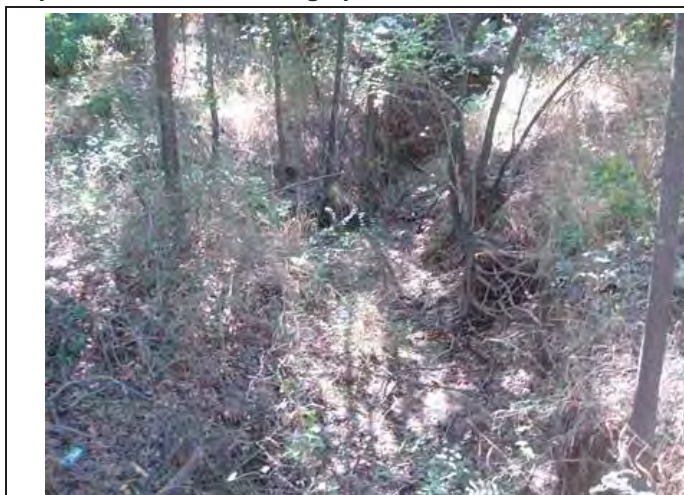
Facing downstream near the downstream end of the SAR. Note the incision and bank erosion.

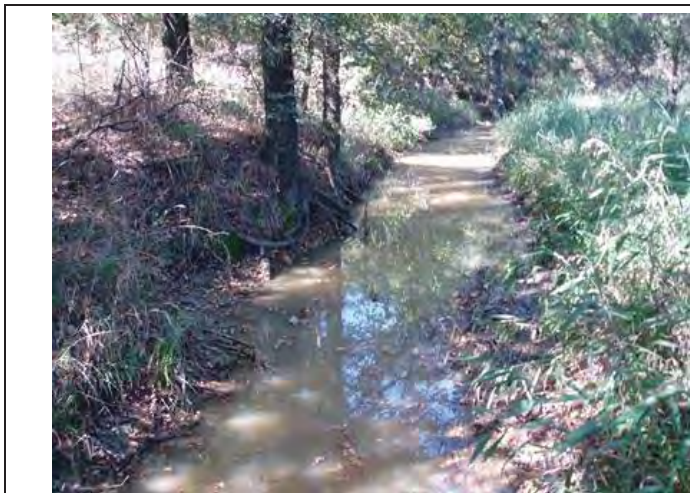
Facing upstream near the downstream end of the SAR. Note the murky water pooled in this reach from runoff of recent rain.

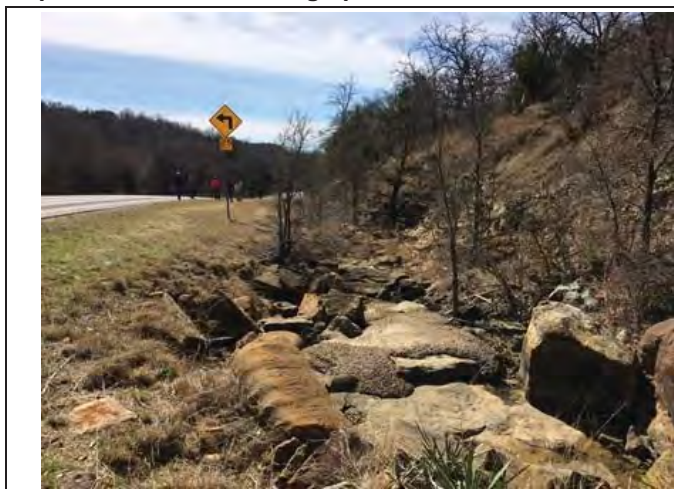
Facing downstream from the middle of the SAR. Note the previous channelization in the ditch along the road and concrete placed in the channel.

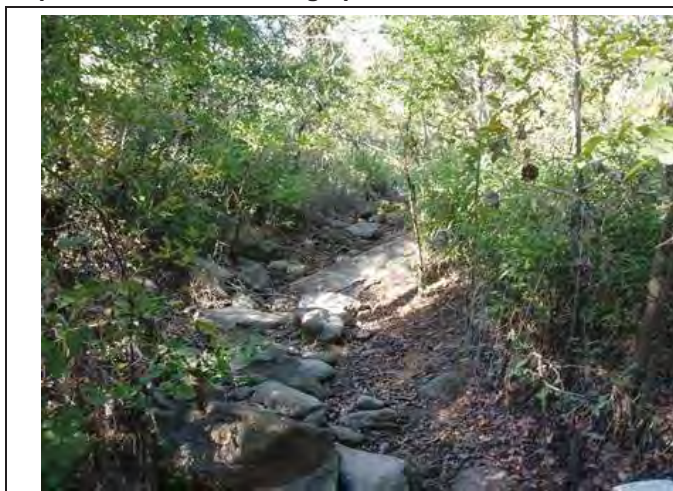
Facing upstream near the lower end of the SAR. Note the mix of rock and fine substrates.

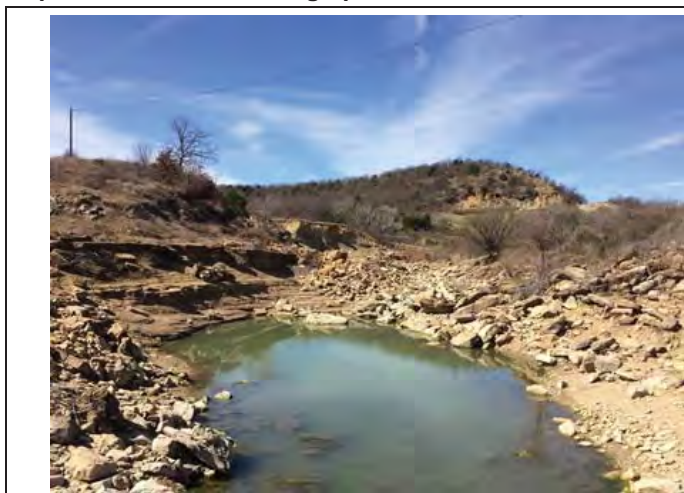
Facing upstream near middle of SAR. Note the high erosion and incision of the spillway channel below Lake Palo Pinto.

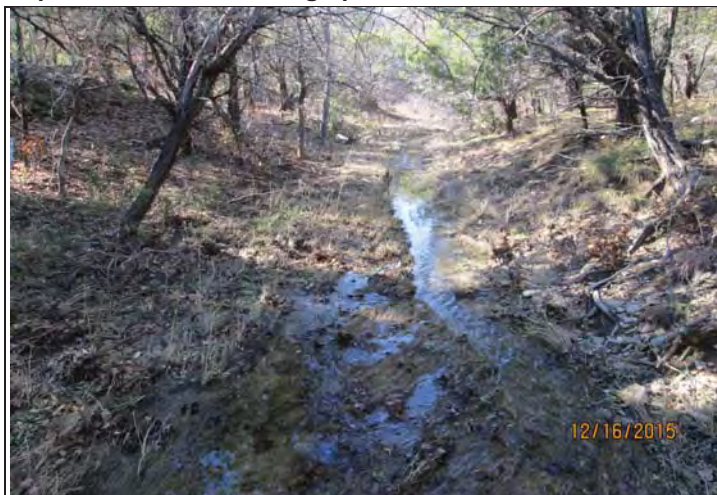
Small Tributary of Palo Pinto Creek facing west-northwest (downstream) from the downstream portion of SAR. Note the wooded riparian buffer.

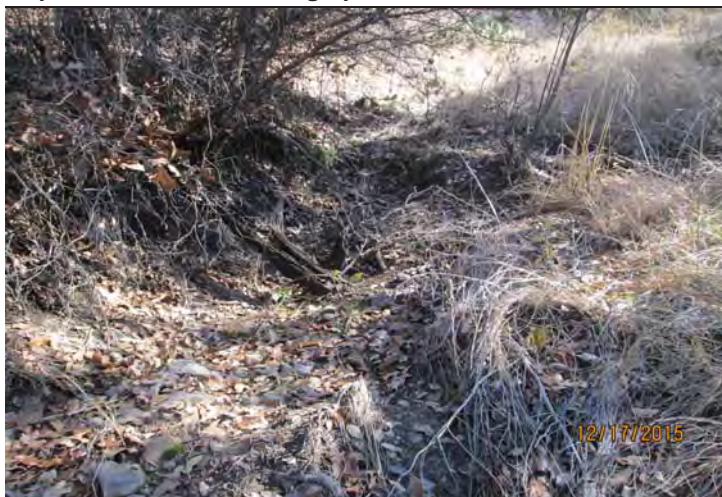
Facing north (upstream) in the central portion of SAR.

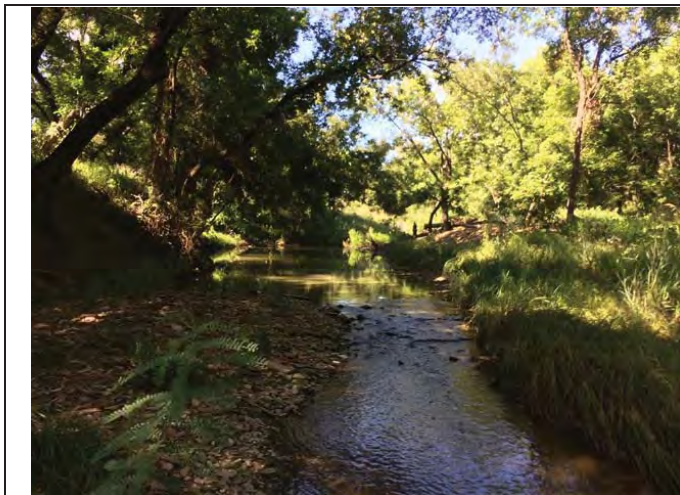
Facing upstream near the middle of the SAR.

Notes: Rock Creek below Lake Mineral Wells in state park. Mature forest in riparian buffer with some ~24" DBH. Nearby grassland restored. Old distribution line noted but does not appear to be maintained.

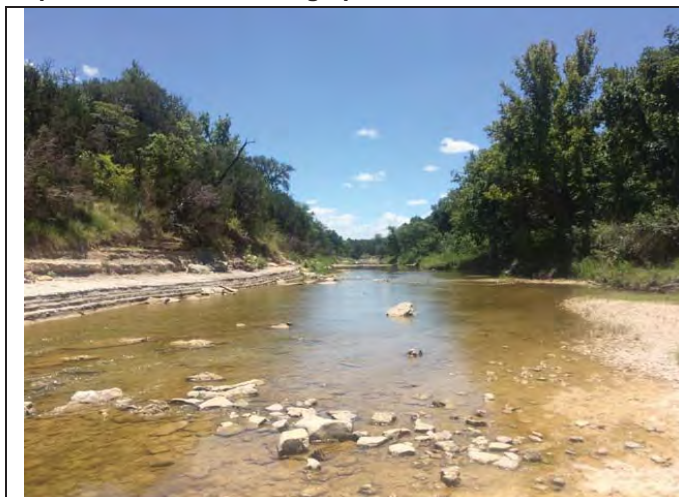
Facing downstream near the upper end of the SAR.

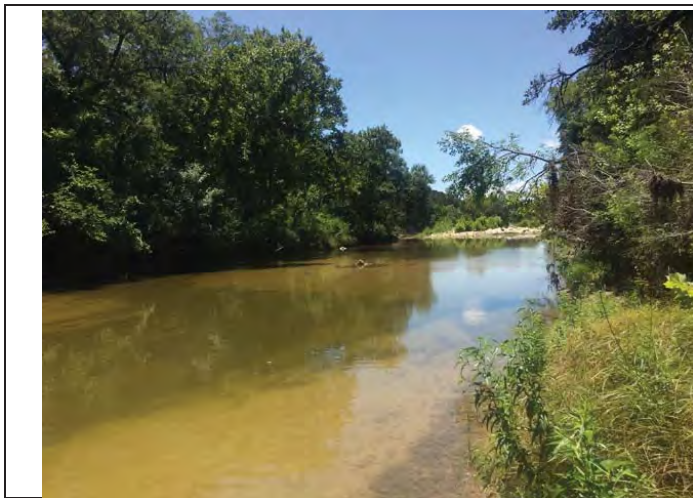
Facing downstream near the middle of the SAR.

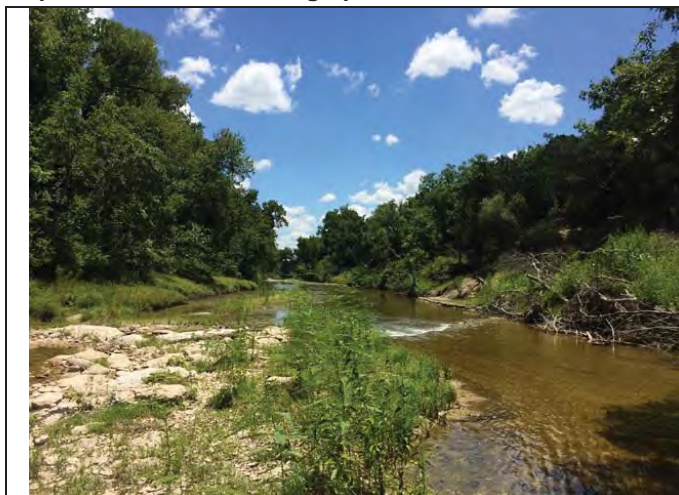
Facing downstream near the lower end of the SAR.

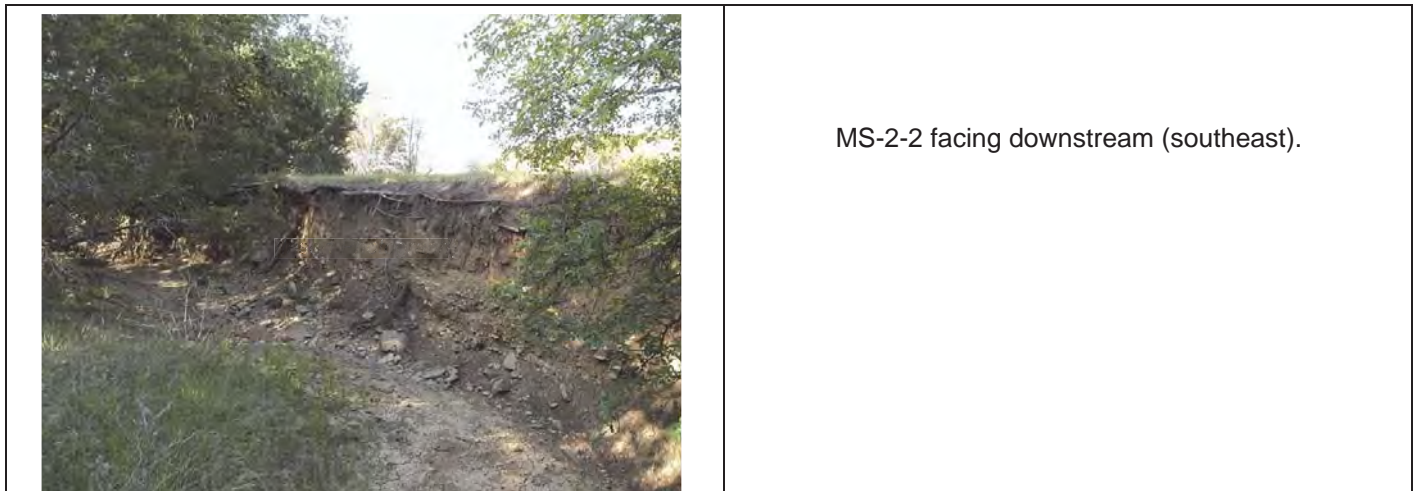
MS-2-2 facing downstream (southeast).

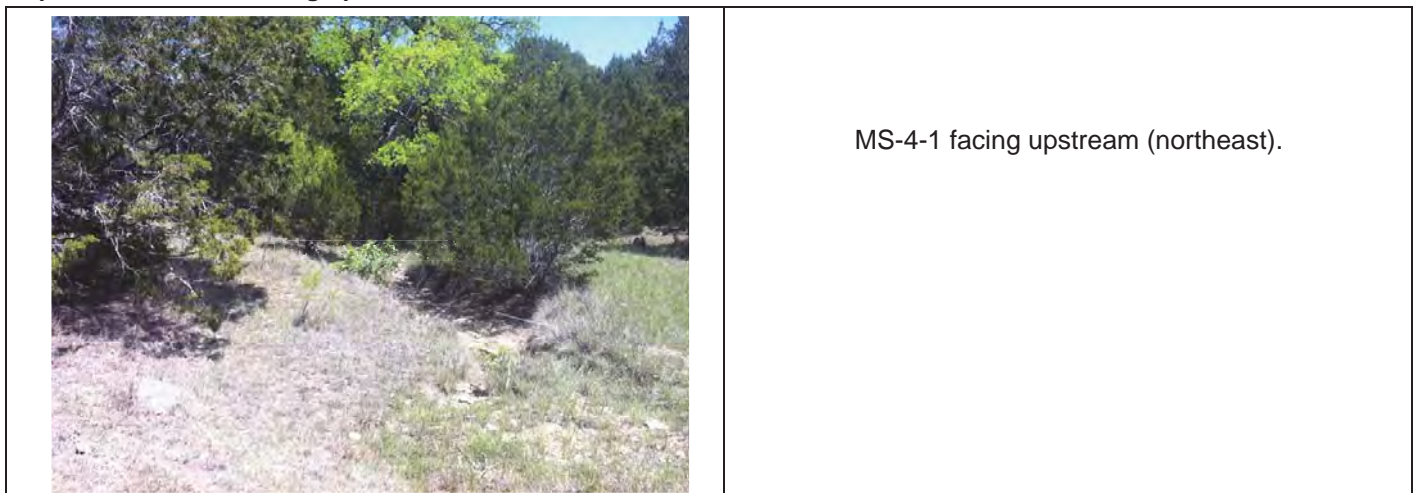
MS-4-1 facing upstream (northeast).

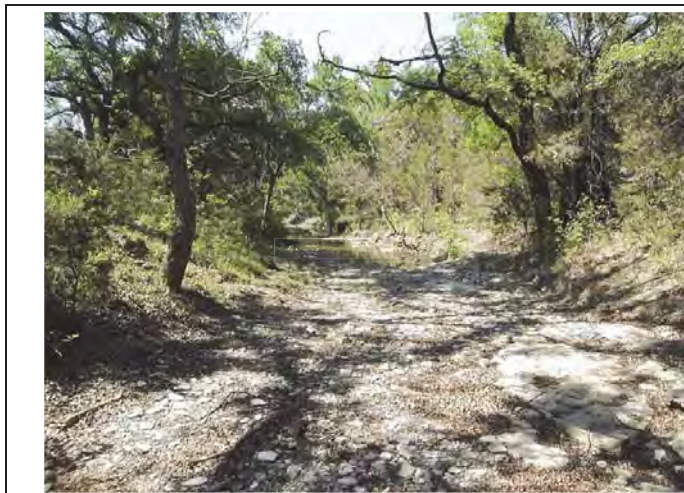
MS-9-1 facing upstream (northwest).

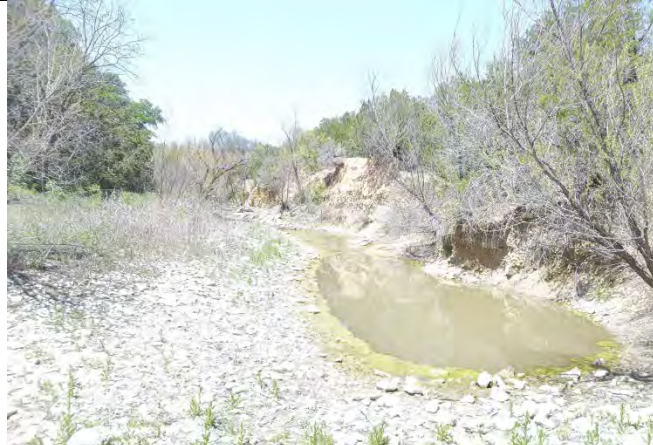
<p>Existing segment of stream (MS-1-1) facing upstream (west). A portion of channel is split with signs of livestock use.</p>	<p>See TXRAM Reference SAR data and description of proposed activities in mitigation plan. After construction includes enhancement of channel and planting vegetation with livestock exclusion.</p>	<p>See TXRAM Reference SAR data and description of proposed activities in mitigation plan. After monitoring includes natural re-generation and growth of vegetation.</p>	<p>See TXRAM Reference SAR data and description of proposed activities in mitigation plan. At maturity includes target scores for mitigation based on reference.</p>
---	---	---	--	--

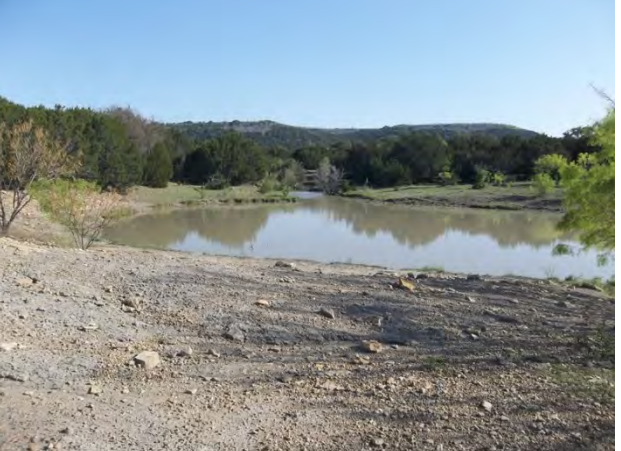
Stream is currently impounded	See design and description of proposed activities in mitigation plan. After construction includes restoration of channel and planting vegetation with livestock exclusion.	See design and description of proposed activities in mitigation plan. After monitoring includes natural regeneration and growth of vegetation, as well as becoming intermittent as described above.	See design and description of proposed activities in mitigation plan. At maturity includes target scores for mitigation based on reference.
---	-------------------------------	--	---	---

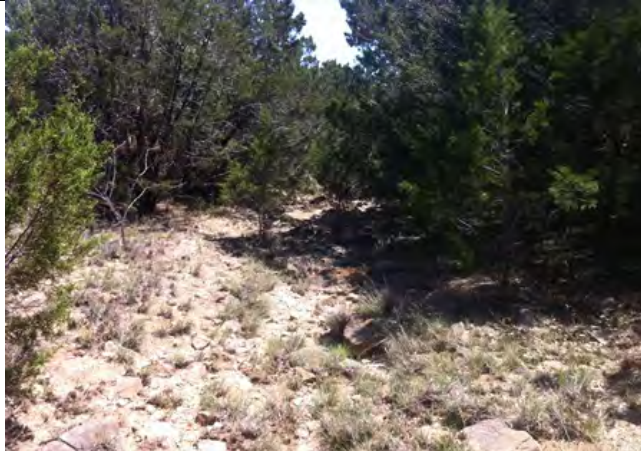
<p>Existing stream section (MS-3-1) facing downstream (south).</p>	<p>See TXRAM Reference SAR data and description of proposed activities in mitigation plan. After construction includes enhancement of channel and planting vegetation with livestock exclusion.</p>	<p>See TXRAM Reference SAR data and description of proposed activities in mitigation plan. After monitoring includes natural re-generation and growth of vegetation.</p>	<p>See TXRAM Reference SAR data and description of proposed activities in mitigation plan. At maturity includes target scores for mitigation based on reference.</p>
---	--	---	--	--

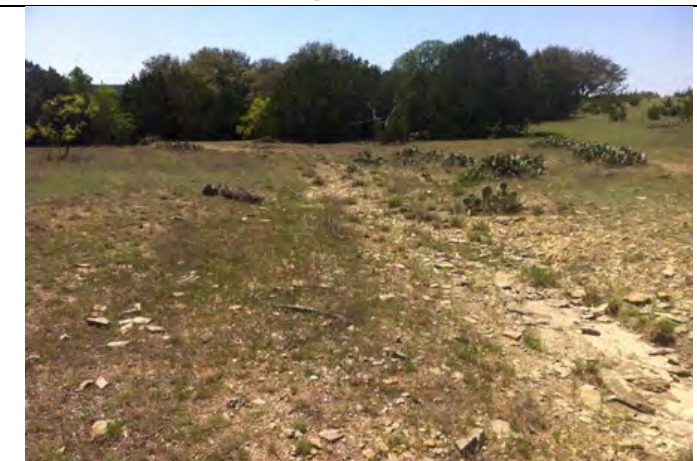
<p>Existing stream section (MS-4-2) facing downstream (southwest).</p>	<p>See TXRAM Reference SAR data and description of proposed activities in mitigation plan. After construction includes enhancement of channel and planting vegetation with livestock exclusion.</p>	<p>See TXRAM Reference SAR data and description of proposed activities in mitigation plan. After monitoring includes natural re-generation and growth of vegetation.</p>	<p>See TXRAM Reference SAR data and description of proposed activities in mitigation plan. At maturity includes target scores for mitigation based on reference.</p>
--	--	---	--	--

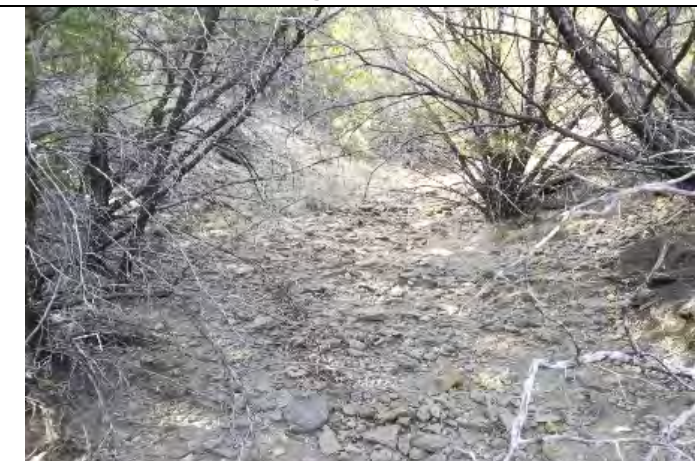
<p>Existing segment of SAR MS-5-1 facing upstream (northwest) from the downstream end. Signs of cattle use.</p>	<p>See TXRAM Reference SAR data and description of proposed activities in mitigation plan. After construction includes enhancement of channel and planting vegetation with livestock exclusion.</p>	<p>See TXRAM Reference SAR data and description of proposed activities in mitigation plan. After monitoring includes natural re-generation and growth of vegetation.</p>	<p>See TXRAM Reference SAR data and description of proposed activities in mitigation plan. At maturity includes target scores for mitigation based on reference.</p>
--	---	---	--	--

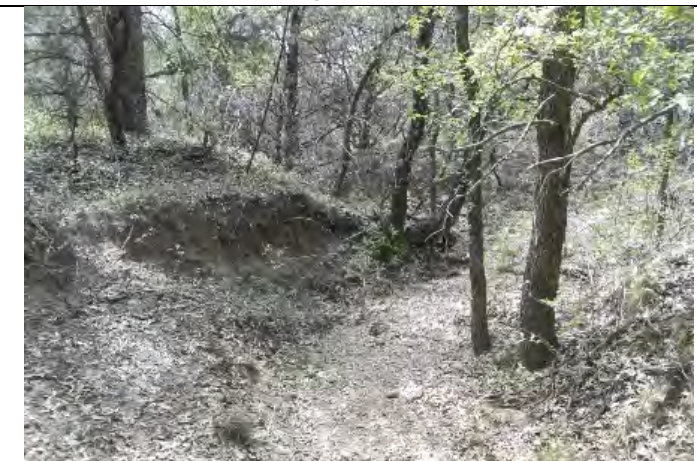
<p>Existing stream section (MS-8-1) facing downstream (south).</p>	<p>See TXRAM Reference SAR data and description of proposed activities in mitigation plan. After construction includes enhancement of channel and planting vegetation with livestock exclusion.</p>	<p>See TXRAM Reference SAR data and description of proposed activities in mitigation plan. After monitoring includes natural re-generation and growth of vegetation.</p>	<p>See TXRAM Reference SAR data and description of proposed activities in mitigation plan. At maturity includes target scores for mitigation based on reference.</p>
--	--	---	--	--

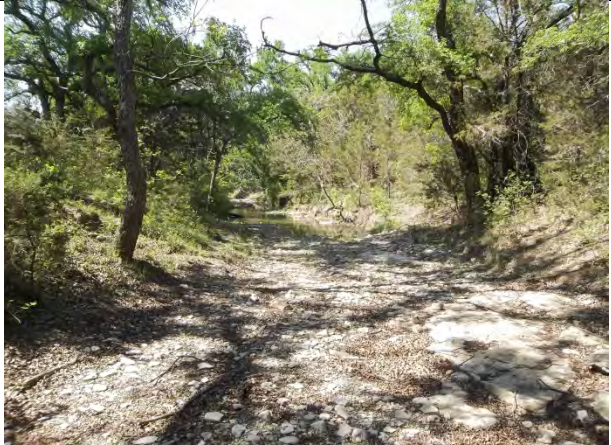
<p>Existing stream segment (MS-9-1) facing upstream (northwest). Area downstream of property boundary to confluence with Palo Pinto Creek. Small pool present in area frequented by livestock.</p>	<p>See TXRAM Reference SAR data and description of proposed activities in mitigation plan. After construction includes enhancement of channel and planting vegetation with livestock exclusion.</p>	<p>See TXRAM Reference SAR data and description of proposed activities in mitigation plan. After monitoring includes natural re-generation and growth of vegetation.</p>	<p>See TXRAM Reference SAR data and description of proposed activities in mitigation plan. At maturity includes target scores for mitigation based on reference.</p>
---	--	---	--	--

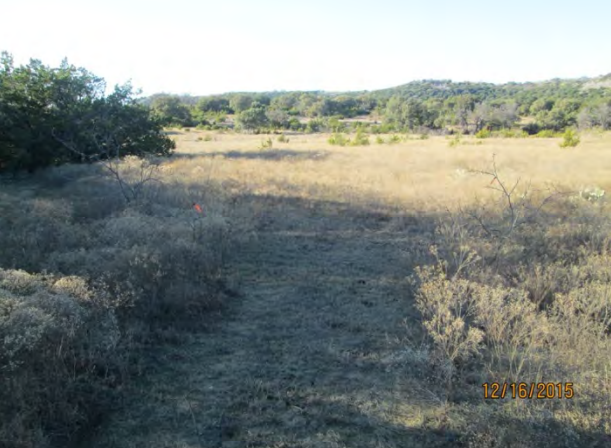
<p>Stream is currently non-existent due to upslope pond.</p>	<p>See design and description of proposed activities in mitigation plan. After construction includes restoration of channel and planting vegetation with livestock exclusion.</p>	<p>See design and description of proposed activities in mitigation plan. After monitoring includes growth of vegetation.</p>	<p>See design and description of proposed activities in mitigation plan. At maturity includes target scores for mitigation based on reference.</p>
---	--	---	--	--

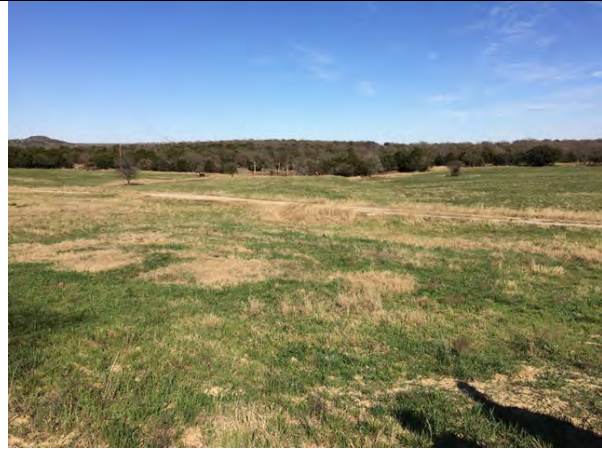
<p>Facing east below and existing pond that will be removed to restore the proposed SAR OPSR-2-1.</p>	<p>See TXRAM Reference SAR data, design and description of proposed activities in mitigation plan. After construction includes restoration of channel and planting vegetation with livestock exclusion.</p>	<p>See TXRAM Reference SAR data, design and description of proposed activities in mitigation plan. After monitoring includes growth of vegetation.</p>	<p>See TXRAM Reference SAR data, design and description of proposed activities in mitigation plan. At maturity includes target scores for mitigation based on reference.</p>
---	---	---	--	--

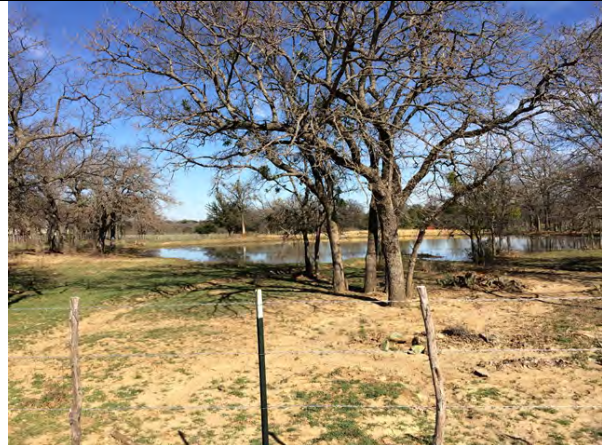
<p>Facing east at existing pond that will be removed to restore the proposed SAR OPSR-17-1.</p>	<p>See TXRAM Reference SAR data, design and description of proposed activities in mitigation plan. After construction includes restoration of channel and planting vegetation with livestock exclusion.</p>	<p>See TXRAM Reference SAR data, design and description of proposed activities in mitigation plan. After monitoring includes growth of vegetation.</p>	<p>See TXRAM Reference SAR data, design and description of proposed activities in mitigation plan. At maturity includes target scores for mitigation based on reference.</p>
---	---	---	--	--

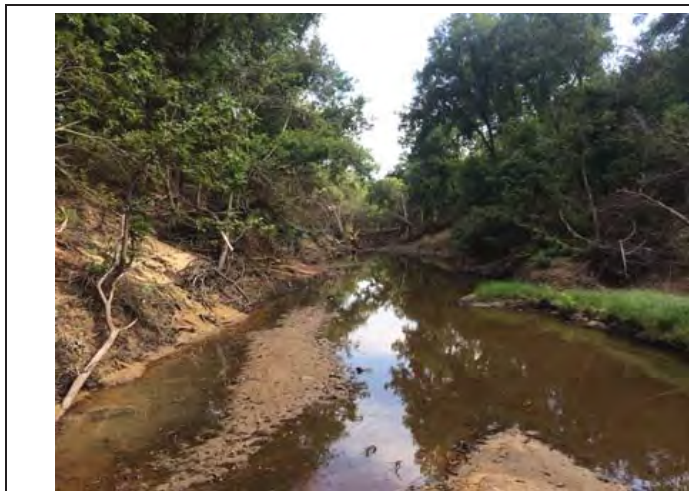
Facing downstream near the upper end of the SAR. Note erosion and sedimentation. A riffle stabilized with construction debris occurs just downstream.
